SUMMARY OF HYDRAULIC MODEL TESTS

HYD-332

HEART BUTTE DAM
Spillway and Outlet Works Model, Scale 1:21.5

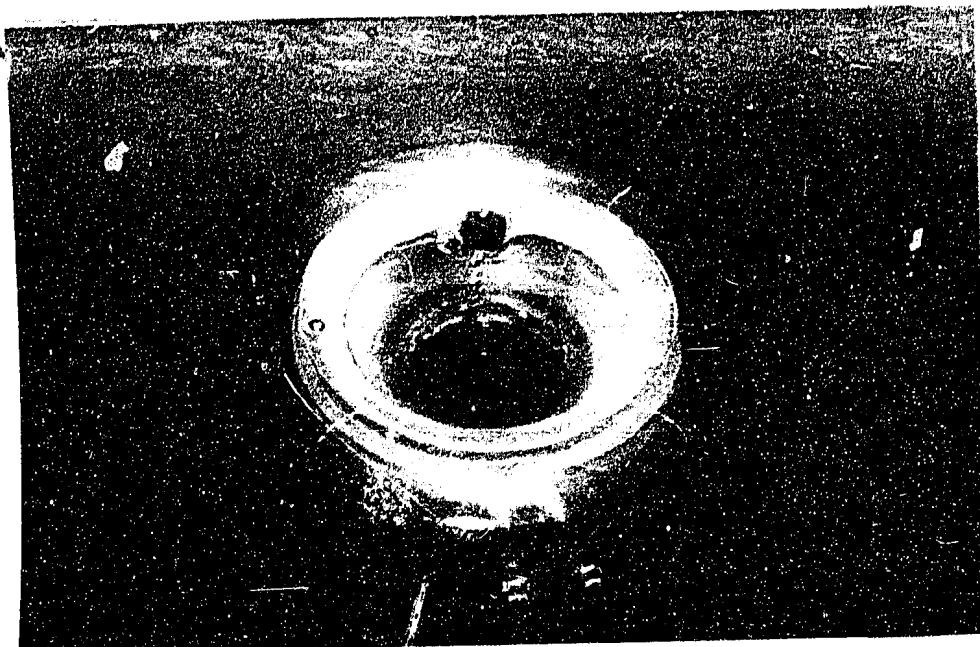
Figure 4

Vortices which formed in the model when the spillway was submerged, Figure 4a, were thoroughly investigated, experimentally and mathematically, and when it was found that these same vortices could form to scale in the prototype, attempts were made to eliminate them. Various arrangements of piers, dividing walls, and floating and fixed shafts were tested, and as a result, six spillway crest piers were recommended for use on the prototype, Figure 4g. It was found unnecessary to extend the piers as high as the maximum headwater elevation, a distance of $\frac{5}{8}$ feet. Since vortex action diminished rapidly when the bend on the crest approached 14 feet, it was necessary to extend the piers only to this height.

A--A violent vortex was formed in the spillway for heads above the submergence point. The tail of the vortex extended down into the horizontal tunnel.

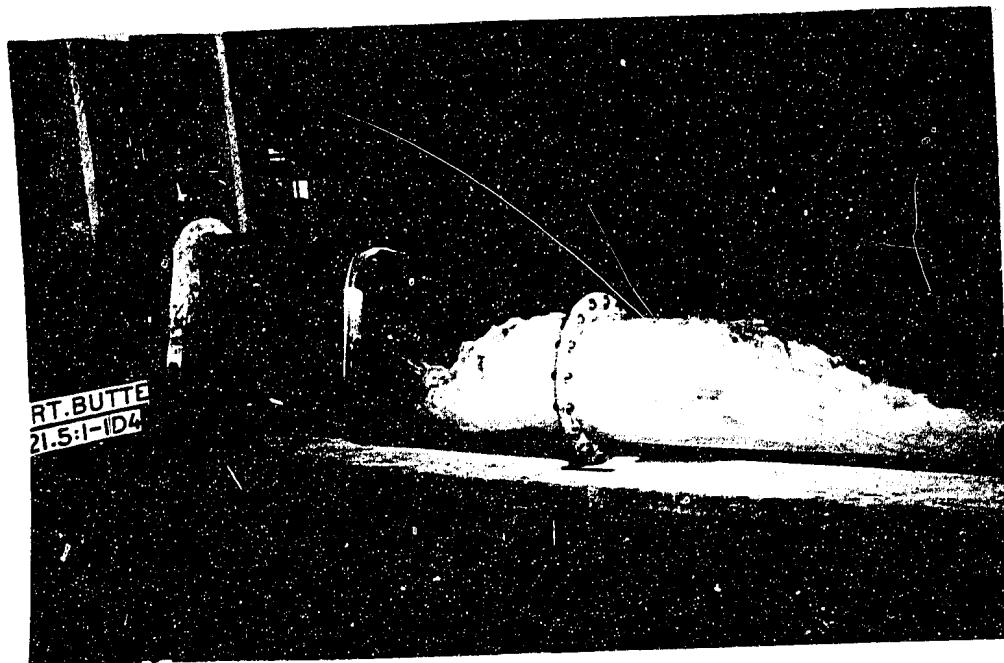
Figure 7

The outlet works discharge entered the spillway tunnel from above in a junction section as shown in Figure 7A. The jet in striking the tunnel bottom caused a "piling up" of water as shown in the photograph. This caused no difficulty unless the spillway was operating at maximum or near maximum flow. In the high spillway discharge range, the resistance caused by the pile-up in the junction section caused the spillway tunnel to fill, an undesirable condition.

A--The short junction section recommended for use in the prototype caused some disturbance in the flow at the entrance to the spillway tunnel.

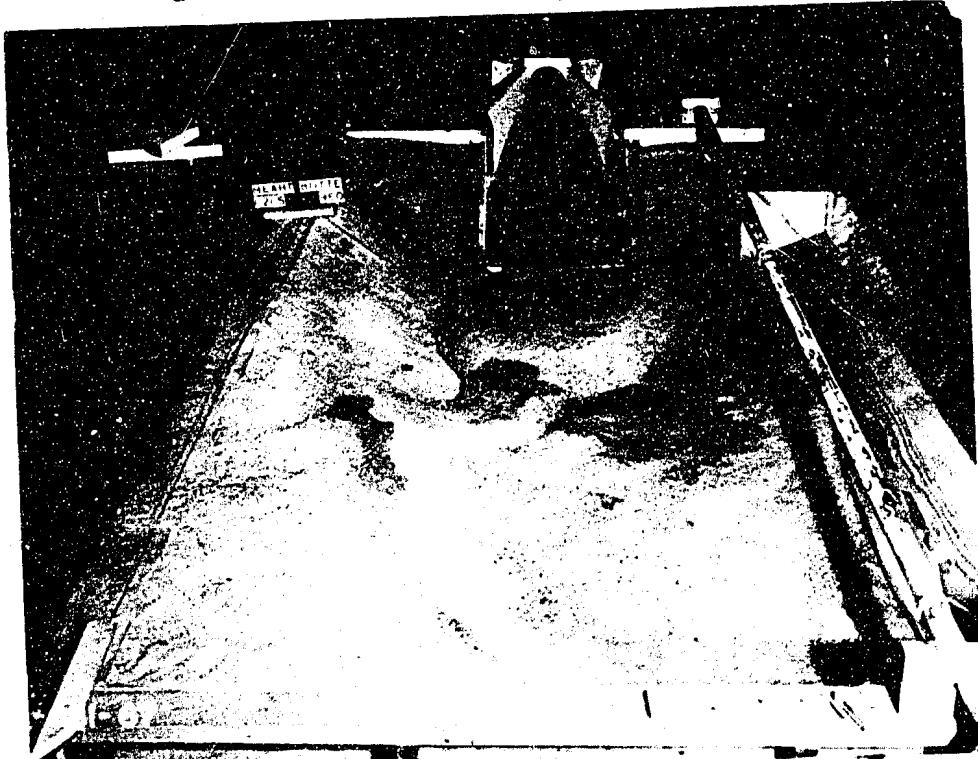
B--Although some erosion occurred the operation was considered acceptable since riprap protection was to be used in the prototype. Model operated 1/2 hour.

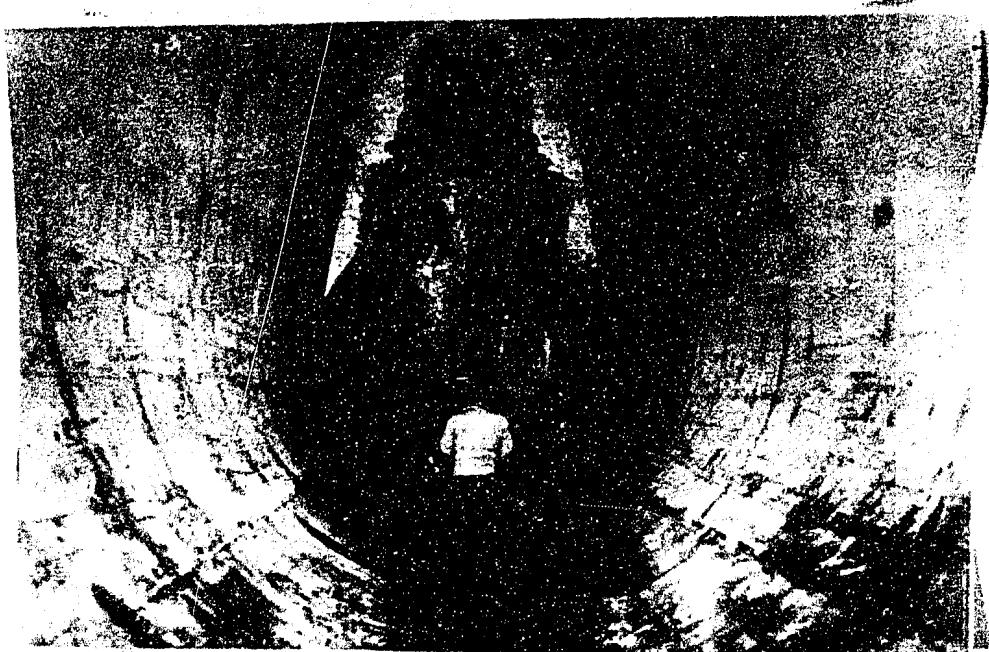
B--Ice in the tunnel, formed from small leaks around the outlet works control gate, was removed before the spillway operated.

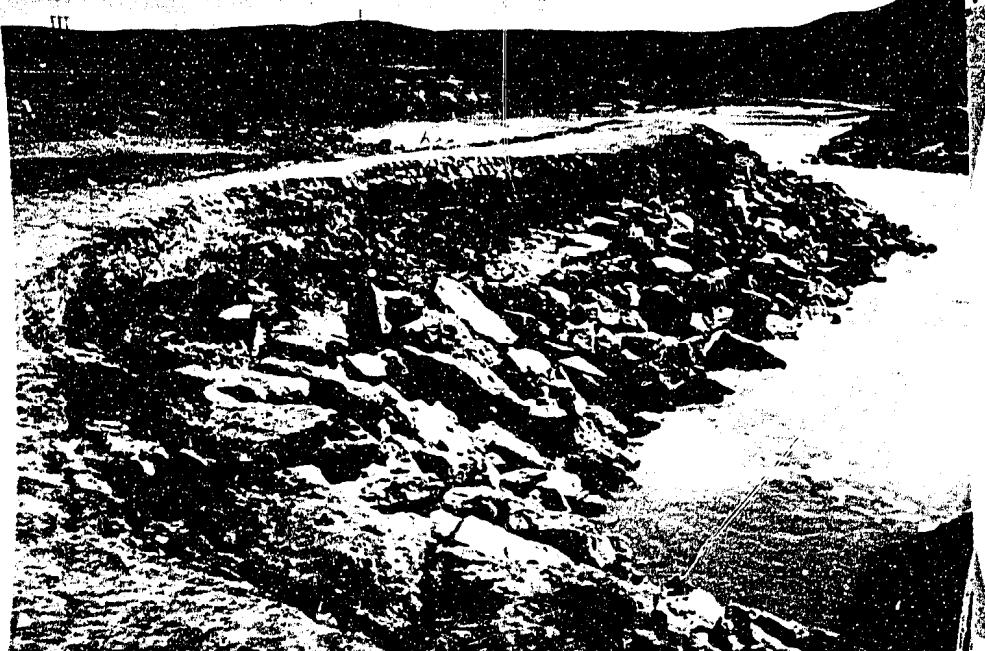
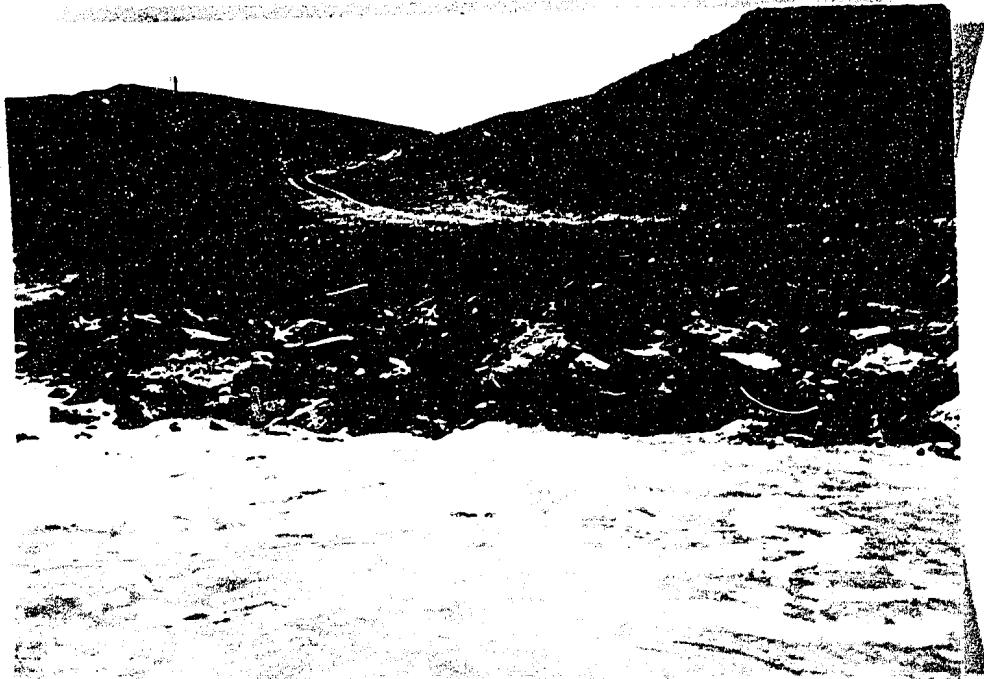
Figure 30

On the other hand, the channel banks, despite their riprap cover, were eroded to a greater degree. The riprap, however, had been placed in a thin layer, was not well graded as to size, and in places the earth banks could be seen between the individual rocks. Swells were observed to rise over local areas and penetrate very easily into the large voids. When the water receded some of the earth was removed from behind the riprap. This was evidenced by the darker, earth-colored water which could be seen adjacent to the riprap. After several days of operation the riprap had slumped and the earth banks had caved as shown in Figure 30. In spite of the apparent damage to the banks the riprap still continued to provide a good measure of protection to further cutting, however.

The bank damage was not caused primarily by waves of the ordinary variety, since there were only a matter of inches in over-all height, but rather by swells caused by surges in the hydraulic jump. The model stilling basin had been equipped with baffle piers and chute blocks to reduce the over-all length of the stilling basin and decrease its cost. It had been noted during these and other model tests that when a hydraulic jump is reduced in length by the use of artificial devices such as baffle piers that the jump becomes more stable in most respects, but does exhibit a tendency to produce the swells discussed above. The swells are considered the lesser of the evils, however, and are not impossible to cope with. With a thicker application of riprap, containing rock well graded as to size, there probably would have been no damage.

A--Loss of bank material was caused by swells removing fine material from behind the coarse riprap. Note man standing on the riprap.

B--Loss of bank material also occurred along the right bank, particularly near the junction of excavated channel and river.

Inspection of the riprap downstream from the stilling basin, following the 1950 flood, indicated that repairs would be advisable. Quoting again from the official report - "The slumped riprap in the channel immediately downstream from the stilling basin structure was repaired in May and June 1950. Gravel backfill was placed on the slopes to bring them to grade and rock replaced over the gravel. The erosion of the riverbank just downstream from the end of the riprapped channel was sloped and covered with gravel and rock."

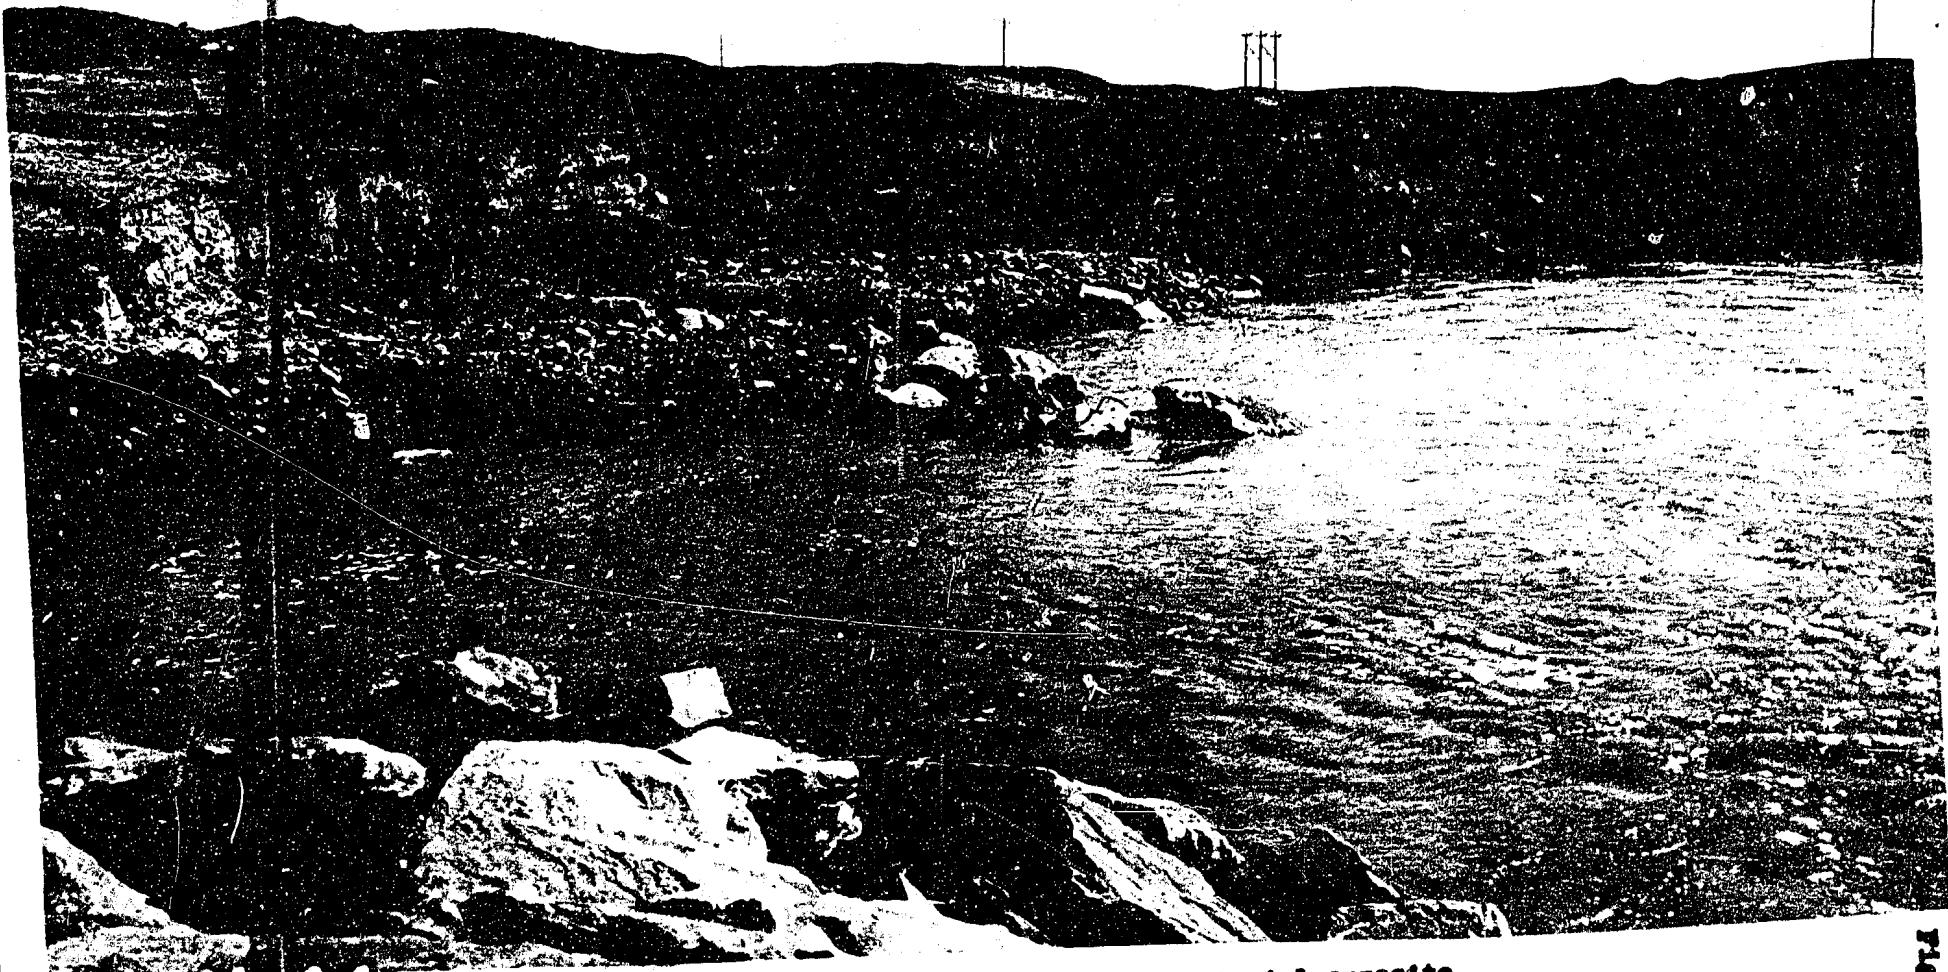
After flood had receded the loss of bank material opposite
the excavated channel was readily apparent.

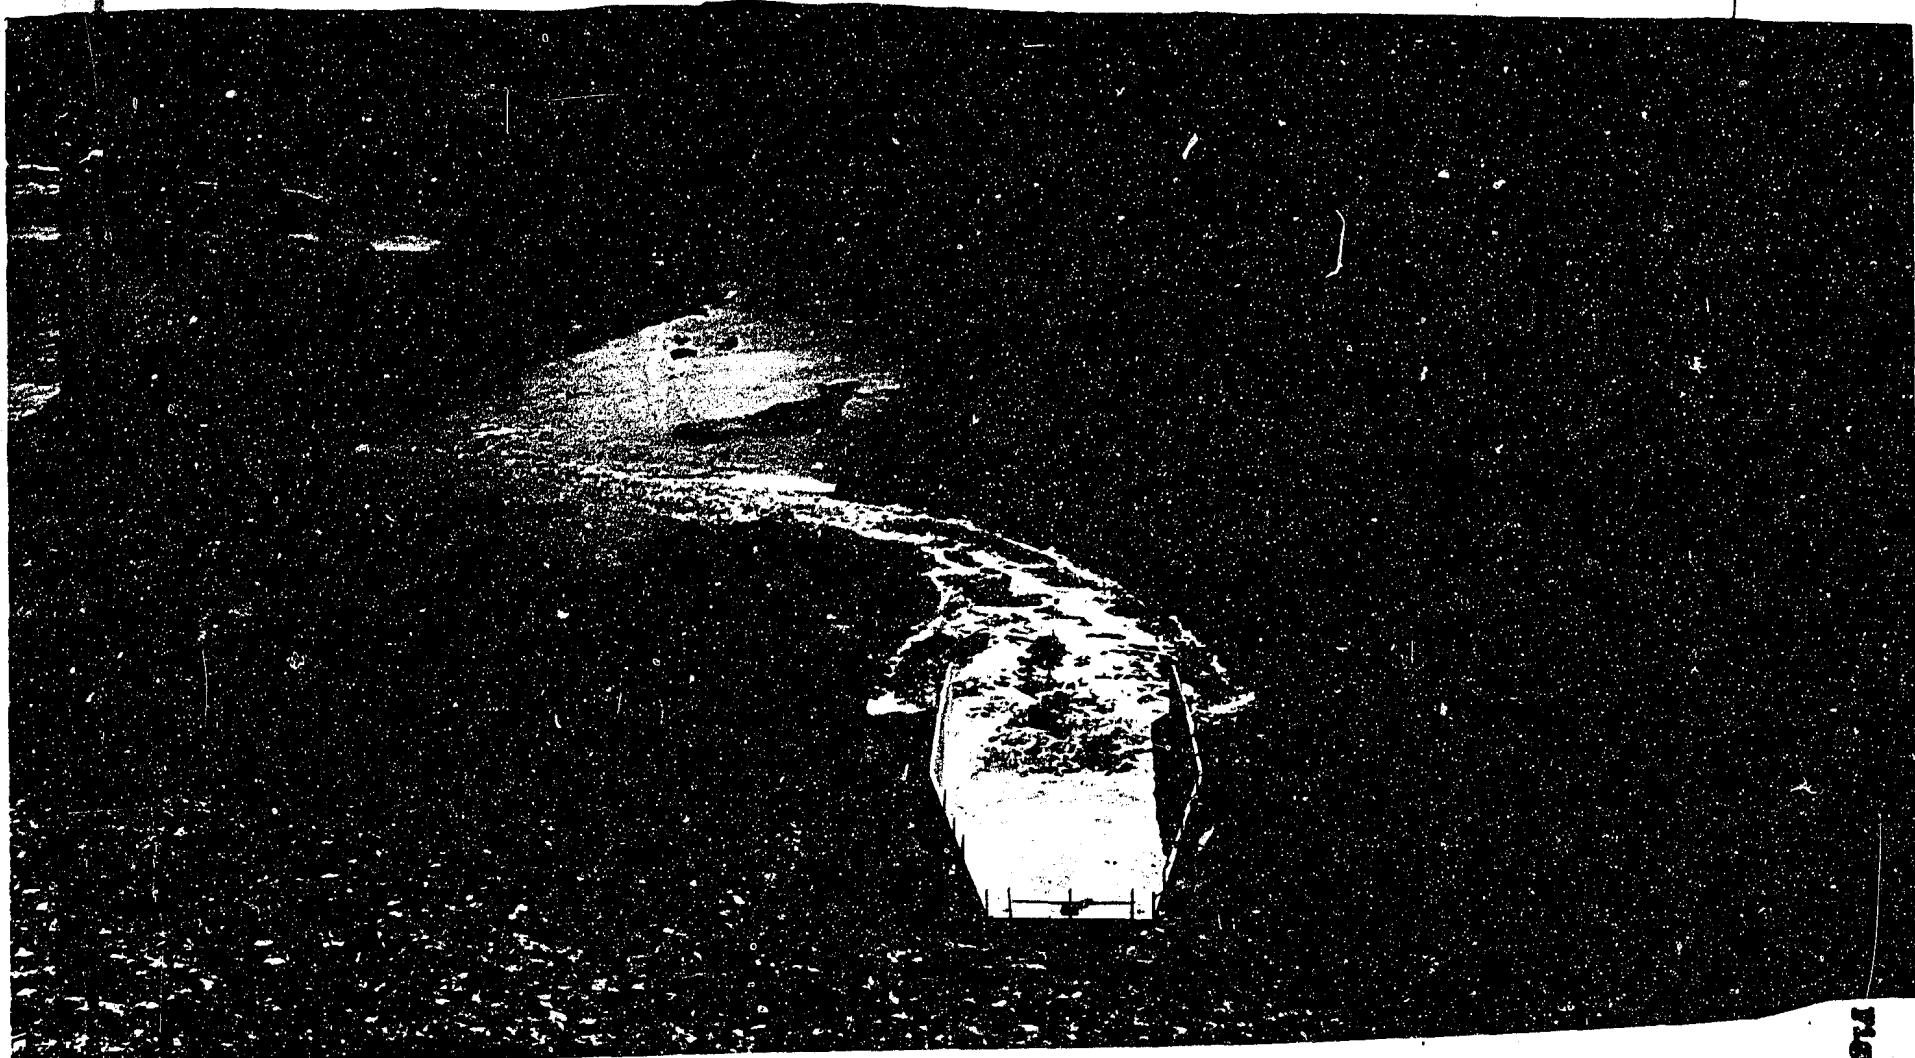
Over-all view after flood had passed shows extent of downstream bank erosion on May 5, 1950. Note bars formed from eroded material. Compare with Figure 23.
